FIFTEENTH ANNUAL REPORT

WATER COMMISSIONER

FOR THE YEAR ENDING
JANUARY 31, 1910

FOR THE YEAR 1909-10.

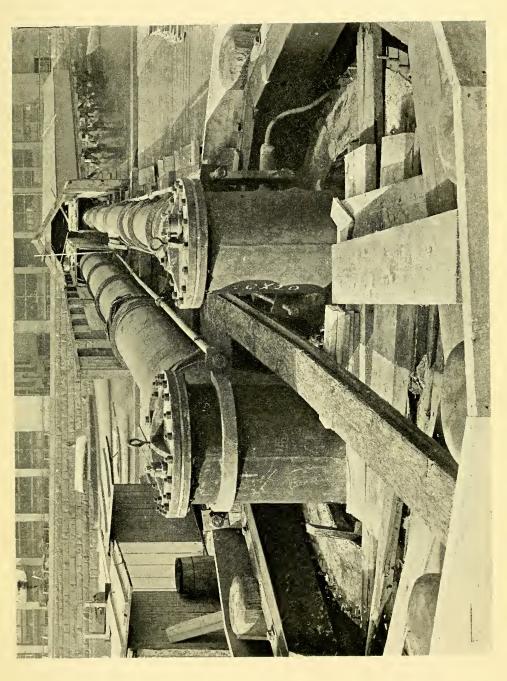
24-INCH LOW SERVICE AND 16-INCH HIGH SERVICE LINES CROSSING PIPE TRESTLE AT CONGRESS STREET TUNNEL AND ENTERING SHAFT OF TUNNEL. HOUSING OF PIPES PARTIALLY CONSTRUCTED. (See Page 46.)

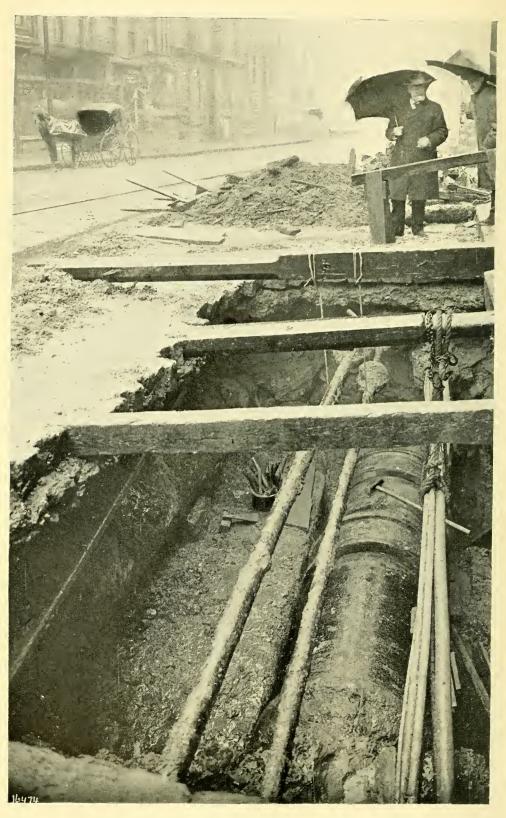
BREAK IN 30-INCH MAIN, TREMONT STREET, OPPOSITE SEAVER PLACE, JAN-UARY 3, 1910; REPAIRED BY PIECE OF PIPE AND TWO SLEEVES. ON THE LEFT IS SEEN ROOF OF SUBWAY AND WESTERLY 30-INCH MAIN RESTING UPON IT. EDISON CABLES AND DUCTS ARE SUSPENDED OVER EASTERLY MAIN. (See Page 49.)

Theaters, the water accumulated to depths of from two to five feet. The performances at all three theaters were prevented, and it was only by the most energetic work on the part of the department that the water was removed and conditions improved so as to allow a resumption of business. At the time the department received notice of the break the emergency automobile and its crew was out answering another call; a delay of about eight minutes occurred on this account, but once upon the spot the gates were closed as quickly as possible. Two 30-inch and one 16-inch gates are all that are necessary to control the line at this point, but as the westerly 30-inch line runs parallel within a few feet distant it was necessary to close the gates on that line before it could be determined which line was broken. Two additional 30-inch gates, therefore, were operated. All this was done in eighty minutes from the time the notice was received at department headquarters. It was a bitter cold night and succeeding day, and the work of removing the water from the cellars and making repairs proceeded with difficulty. We were handicapped by a lack of efficient pumping apparatus, and I wish to say here that, if the department expects to cope successfully with breaks of a similar nature, it will have to provide itself with an equipment of power pumps. The ordinary hand diaphragm pump is practically of no value in emergencies of this nature. The cause of the break was the concrete placed over a sewer and under our pipe. This faulty condition was created when the pipe was shifted to the east in 1896 to make room for the arch of the subway. The concrete was not laid for the entire distance under our pipe. It was placed just at the point of fracture and it was the uneven resistance combined with natural settlement that produced the break.

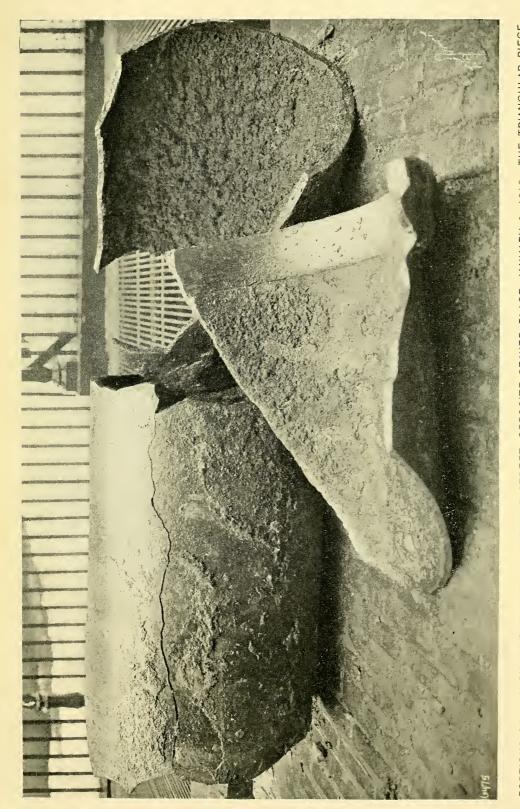
PORTIONS OF 30-INCH PIPE BROKEN IN TREMONT STREET, OPPOSITE SEAVER PLACE, JANUARY 3, 1910. THE TRIANGULAR PIECE IN FOREGROUND WAS BLOWN OUT. THE CRACK IN LARGE PIECE RAN THE WHOLE LENGTH OF PIPE (9 FEET). THE PIPE WAS LAID IN 1848. (See Page 49.)

department. Upon the basis of settlements thus far made I should estimate the total damage at \$23,000. The cost of repairing the break was \$885.66. The cost of pumping out and cleaning the cellars and clerical
